NUMBER: 08-002-05

Headlamp Condensation

This bulletin involves improving the headlamp housing ventilation by installing new style vents and plugs.

2004 - 2005 (ZH) Crossfire Coupe/Crossfire Roadster

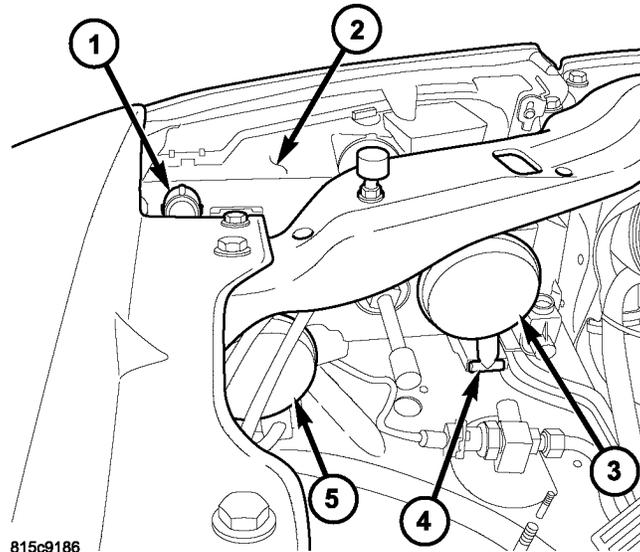
Fig. 1 HEADLAMP HOUSING IN VEHICLE

The vehicle operator may describe that moisture accumulates on the inside of the lens in one or both headlamp housings.

1. Open the hood.
2. Install a battery charger and verify that the charging rate provides approximately 13.5 volts.
3. Remove the vent hoses and the rubber caps from the **both** headlamp housings (Fig. 1).

-
4. Turn on the headlamps, including the high beams. Allow the headlamps to remain on for a minimum of 45 minutes or until the headlamp housings dry out. When both headlamp housings are dry, proceed to the next step. **The headlamps are to remain "On" until Step #9.**
 5. Beginning on the left side of the vehicle, install two of the small rubber plugs from the new seal kit; on the headlamp housing where the vent hoses were previously removed, (#1 & #4) (Fig. 1).

- 6. Install the new rubber cap with the special vent on the large inboard hole in the headlamp housing (Fig. 1).
- 7. Install the large rubber cap that was removed in Step #1 on the large outboard hole in the headlamp housing (Fig. 1).
- 8. Repeat Step #5 through Step #8 on the right side of the vehicle. When Step #5 through Step #8 have been completed on both sides of the vehicle, proceed to the next step.

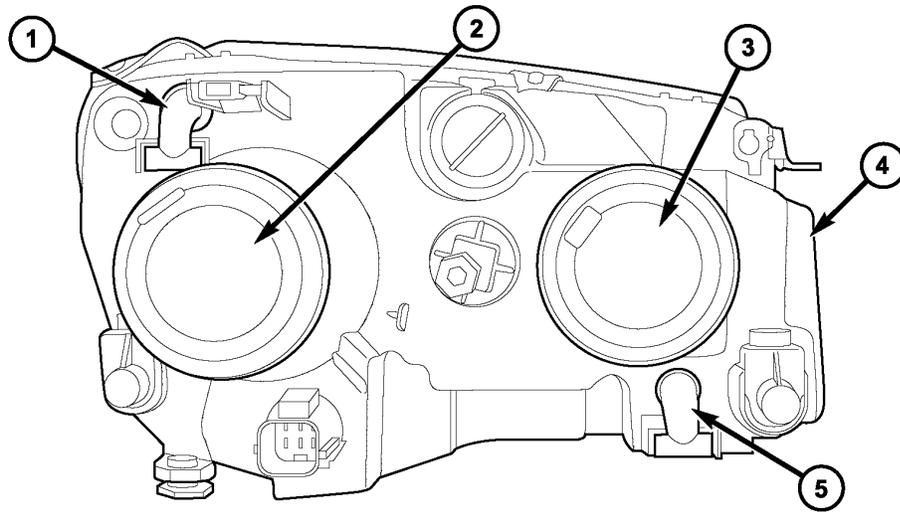
Fig. 2 HEADLAMP HOUSING PRIOR TO REPAIR PROCEDURE

- 1 - UPPER HEADLAMP VENT (DISCARD)
 - 2 - LARGE OUTBOARD RUBBER CAP (REUSE)
 - 3 - LARGE INBOARD RUBBER CAP (DISCARD)
 - 4 - LEFT HEADLAMP HOUSING
 - 5 - LOWER HEADLAMP VENT (DISCARD)
-

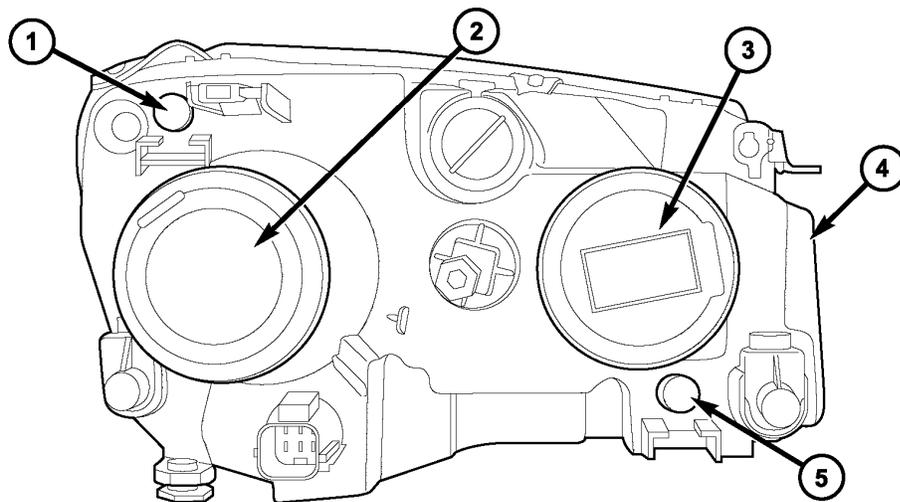
Fig. 3 HEADLAMP HOUSING AFTER REPAIR PROCEDURE

- 1 - NEW SMALL RUBBER PLUG
 - 2 - ORIGINAL LARGE OUTBOARD RUBBER CAP
 - 3 - NEW LARGE INBOARD RUBBER CAP WITH SPECIAL VENT
 - 4 - LEFT HEADLAMP HOUSING
 - 5 - NEW SMALL RUBBER PLUG
-
