**NUMBER:** 23-004-05

Door Glass Misalignment Or Contacts The Roof

2004 - 2005 (ZH) Crossfire Coupe/Crossfire Roadster

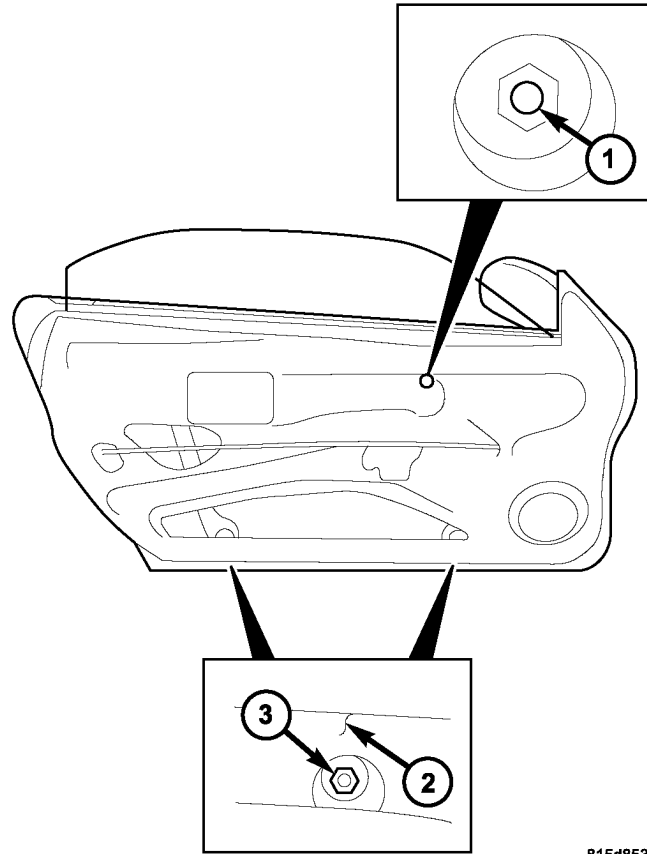
**Fig. 1 WINDOW REGULATOR**

The vehicle operator may describe that the door glass contacts the roof when opening or closing the door. This condition could also result in other side glass misalignment issues such as wind like sound or water leaks into the passenger compartment.

1. Remove the trim panel and weather shield from the door. Refer to the service information available in TechCONNECT. Reference: Service Info, Group 23 - Body/Door - Front/Trim Panel - Removal.
2. Replace the upper window regulator nut with p/n 05097674AA nut ([Fig. 1](#)).

**NOTE: If p/n 05097674AA nut is not available, the technician may remove the old nut and apply p/n 04318031 Mopar Lock & Seal Adhesive to the threads of the nut and install.**

- 
- 3. Adjust the door glass as necessary and ensure that the door glass no longer contacts the roof. Refer to the service information available in TechCONNECT. Reference: Service Info, 23 - body/Door - Front/Door Glass - Adjustments.
  - 4. When the glass is properly adjusted, torque the upper nut to 9 N·m (80 in. lbs.).
  - 5. Install the door trim panel. Refer to the service information available in TechCONNECT. Reference: Service Info, Group 23 - Body/Door - Front/Trim Panel - Installation.
