NUMBER: 23-014-04

Wind Sound While Driving

This bulletin involves adjusting the door glass as required.

2004 (ZH) Crossfire

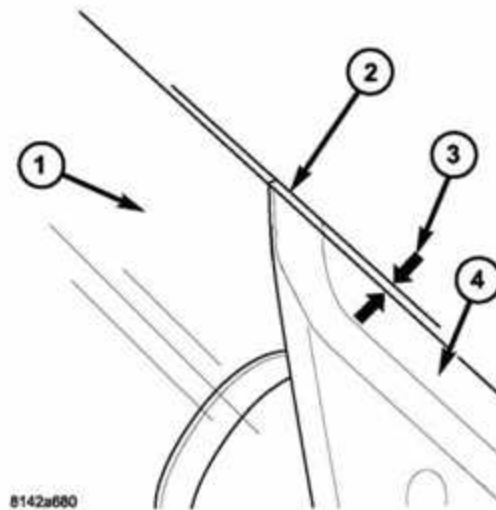
Fig. 1 DIMENSION AT MIRROR TRIANGLE

1. Raise the door glass all the way up. There should be a 1 mm (0.04 in.) bulge in the rubber above the upper edge of the sealing mirror triangle ([Fig. 1](#)).

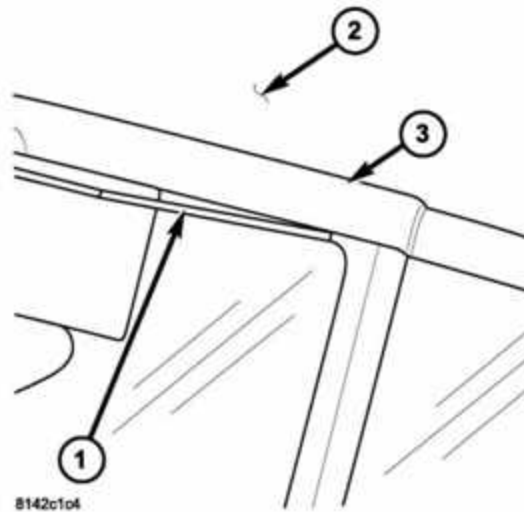
Fig. 2 CHECKING GAP AT ROOF SEAL

2. Check the window height to the roof weather-strip when the door is latched in the first catch position. The gap must be between 1 and 2 mm (.04 - .08 in.) from the upper edge of the glass to the roof weather-strip as shown in (Fig. 2).

11. Adjust the window height so the gap is between 1 and 2 mm (.04 - .08 in.) from the upper edge of the glass to the roof weather-strip as shown in (Fig. 2).
12. Lower the door glass and tighten both window stop bracket bolts.
13. Check to insure the gap is correct.
14. With the door latched in the second catch position (closed tight), the edge of the window glass must disappear completely under the roof weather-strip(Fig. 3).

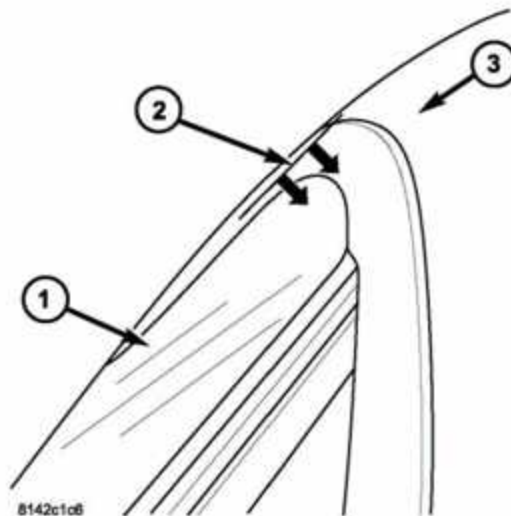
Fig. 3 WINDOW GLASS AT ROOF SEAL

- 3. With the door latched in the second catch position (closed tight), the edge of the window glass must disappear completely under the roof weather-strip (Fig. 3) .

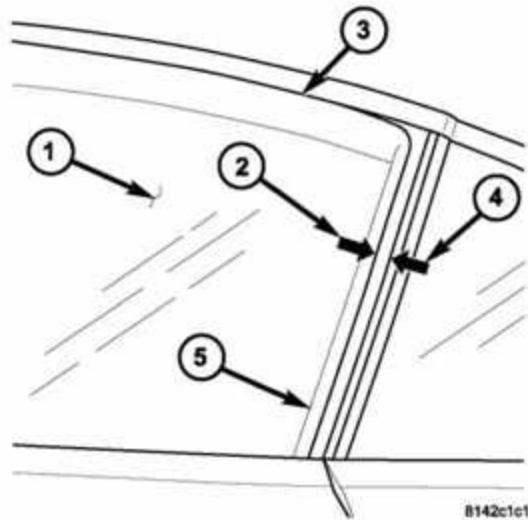
Fig. 4 DOOR GLASS AT B-PILLAR

4. Check the glass to B-pillar weather-strip. The dimension from the rear edge of the glass to the front edge of the sealing flap on the B-pillar weather-strip is 7 - 9 mm (.28 - .35 in.) (Fig. 4).

15. Check the glass to B-pillar weather-strip. The dimension from the rear edge of the glass to the front edge of the sealing flap on the B-pillar weather-strip is 7 - 9 mm (.28 - .35 in.) (Fig. 4).
