**NUMBER:** 23-047-04

Wind-Like Sound From Mirror Flag Area Above 80 Km/h (50 mph)

2004 - 2005 (ZH) Crossfire Coupe/Crossfire Roadster

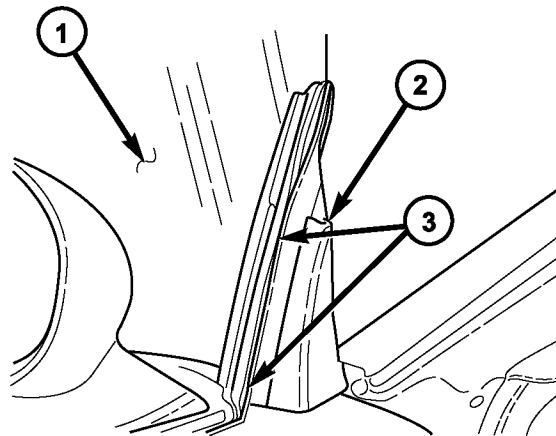
Inspect the door mounted weatherstrip seal lip for contact to the door glass at the mirror flag. The seal lip should contact the glass from the base to near the top. If the seal contacts the glass from the base to near the top on both doors, further diagnosis is necessary and this bulletin does not apply. If there is a gap between the weatherstrip seal lip and the glass, perform the Repair Procedure ([Fig. 1](#)).

**Fig. 1 WEATHERSTRIP AWAY FROM GLASS AT THE BOTTOM**

- 1 - GLASS  
 2 - MIRROR FLAG BEZEL  
 3 - SEAL SHOULD CONTACT THE GLASS IN THIS AREA

8. Inspect the door mounted weatherstrip seal lip for contact to the door glass at the mirror flag. The seal lip should contact the glass from the base of the mirror triangle to near the top of the mirror triangle (Fig. 1). If the seal contacts the glass properly the repair is complete. Verify the sound is no longer present. If there is a gap between the weatherstrip seal lip and the glass, recheck the inner window seal guide width that was adjusted in Step #4.

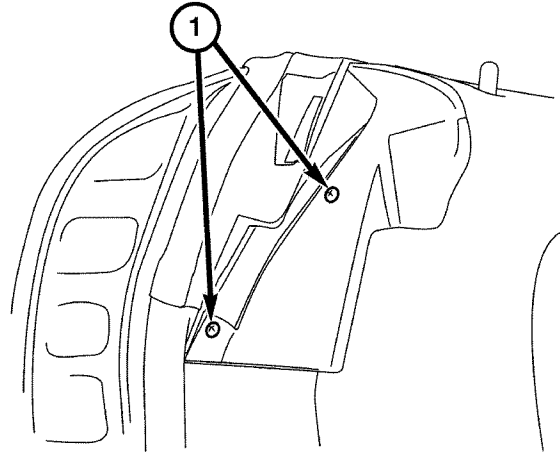
**Fig. 2 DOOR END COVER**

1 - COVER SCREWS

2. Remove the inner window sealing rail by opening the window and pressing the sealing rail off of the inner door with a plastic wedge. Check the clips for wear or damage.
3. Remove the outer window sealing rail by removing the door end cover screws (Fig. 2). Remove the rubber door seal by pulling the seal off of the door at the separation point (about 3-4 inches down the back of the seal).

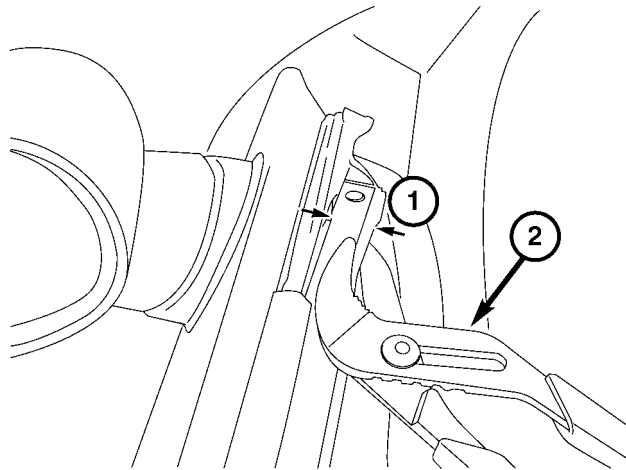
**Fig. 3 WEATHERSTRIP FLANGE ADJUSTMENT**

1 - WINDOW SEAL GUIDE WIDTH = 14-15 MM (0.5-0.6 IN.)

2 - TAPE COVERED PLIERS

4. **Verify that the inner window seal guide width is between 14 and 15 mm (0.5-0.6 in.).** If necessary, bend the guide with tape-covered pliers to achieve the correct gap (Fig. 3).
