NUMBER: 23-051-04

Liftgate Bumper Fastener Will Not Tighten

2004 - 2005 (ZH) Crossfire Coupe

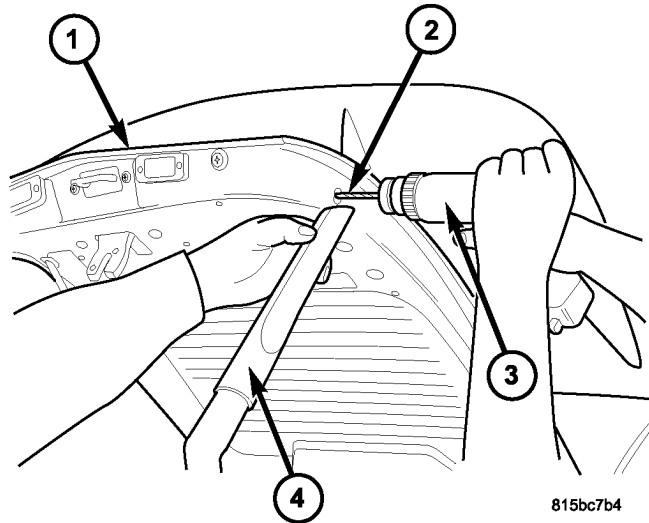
Fig. 1 DRILL OUT WELDED NUT

The technician may find that the liftgate bumper fastener will not tighten.

2. Using a drill motor with a 6.2 mm (0.25 in.) drill, drill out the welded nut.

-
- 3. Using the 05174467AA screw and the 05097674AA nut, fasten the bumper to the liftgate.
 - 4. Position and adjust the liftgate bumper. Refer to the service information available in TechCONNECT. Reference: Service Info, Group 23 - Body/Decklid/Hatch/Liftgate/Tailgate - Adjustments.
 - 5. When the adjustment is complete, tighten the fastener to 10 N·m (88 in. lbs.).
 - 6. Install the lower liftgate trim panel. Refer to the service information available in TechCONNECT. Reference: Service Info, Group 23 - Body/Decklid/Hatch/Liftgate/Tailgate/Trim Panel - Installation.
